Project Information:	Project Scope:	Contacts:
The Creamery	Ammonia Refrigeration System:	Fernando Ortiz - Plant manager
621 Western Ave.	2019 CalARP Seismic Assessment	Larry Peter - owner
Petaluma, CA 94952	2015 Hazard Review - PHA	George Bennett MPE Services (951) 735-4418 georgeb@mpeservicesinc.com
(707) 762-3446	2020 Hazard Review - PHA	
Contact:

Ammonia Refrigeration System CalARP Seismic Assessment

5-Year Hazard Review of the Ammonia Refrigeration System

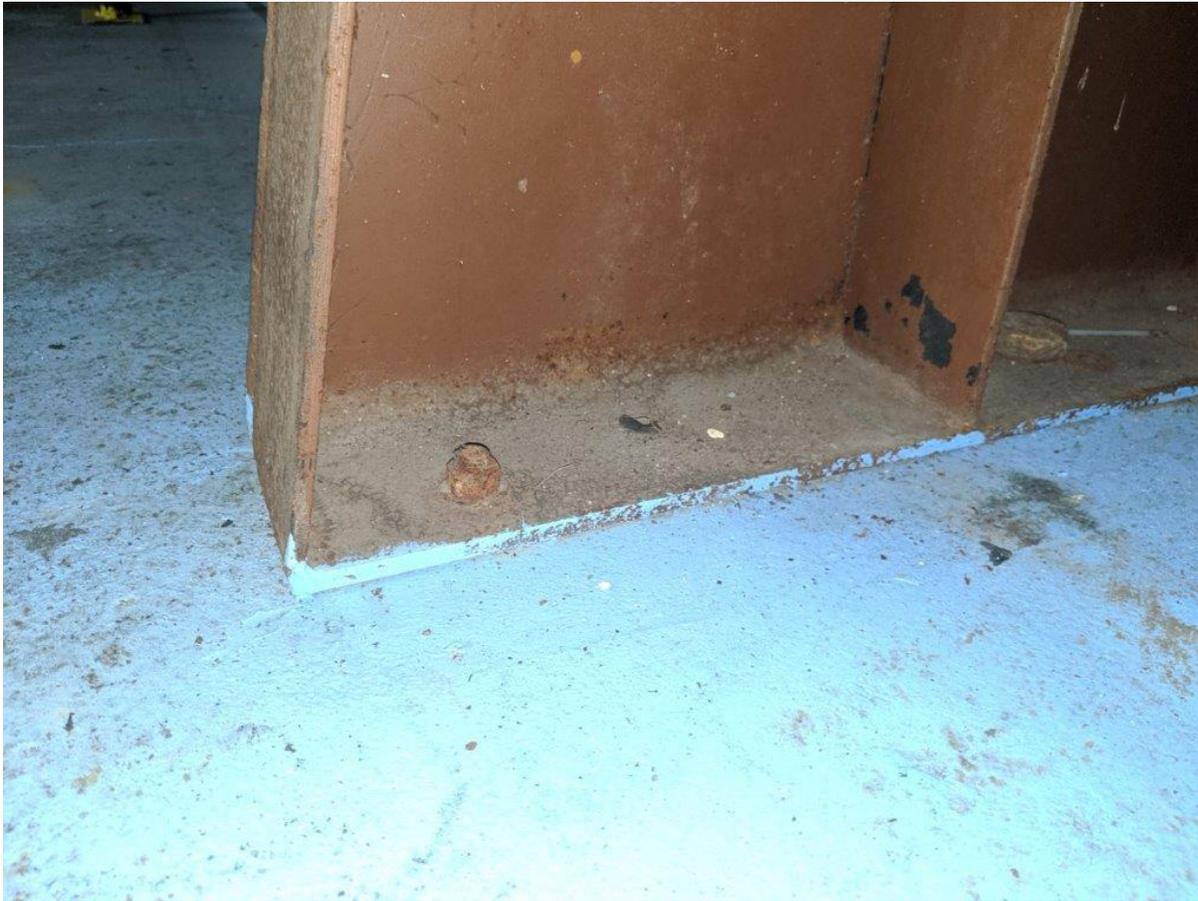
Caption 2. High Pressure Receiver Anchorage (Typical) [[Action Item 1](#)]

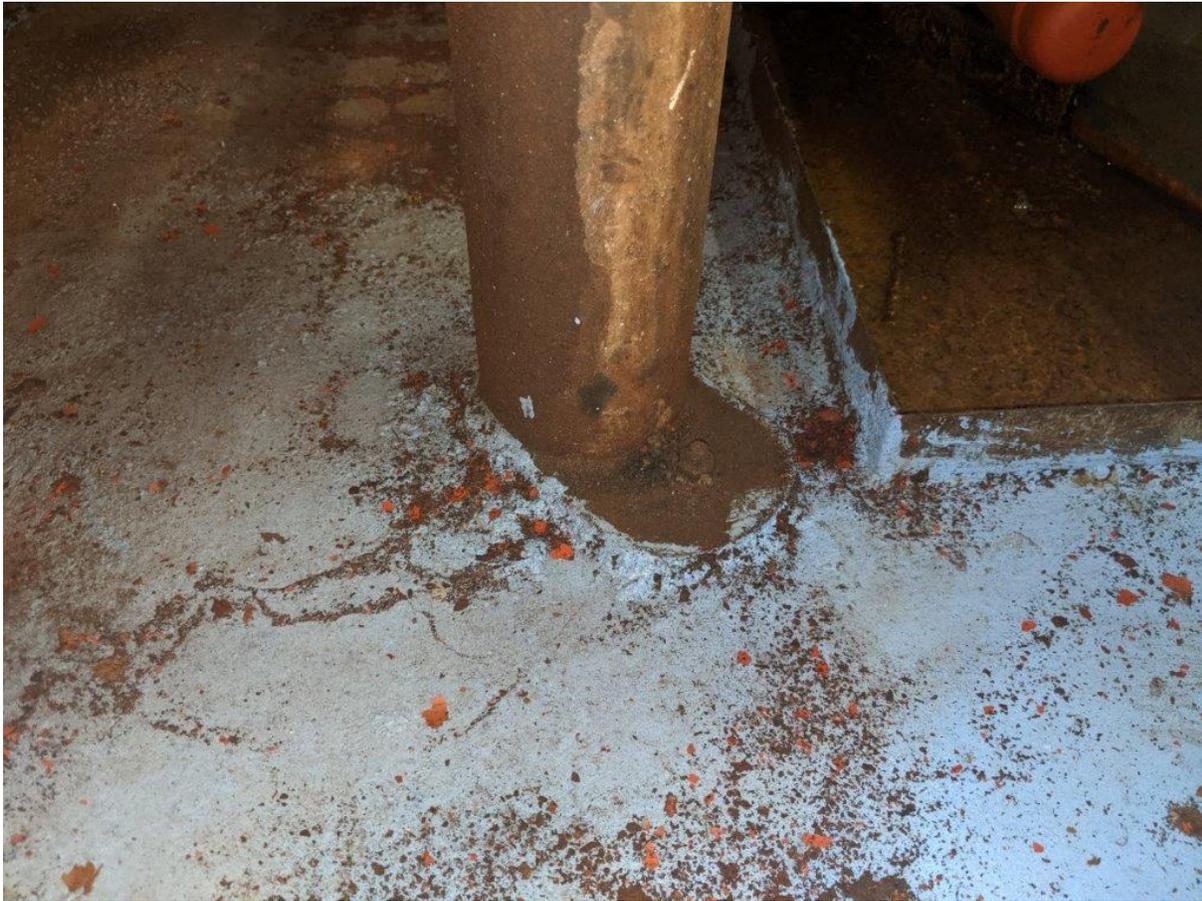
Caption 4. Suction Accumulator Anchorage (Typical) [[Action Item 1](#)]

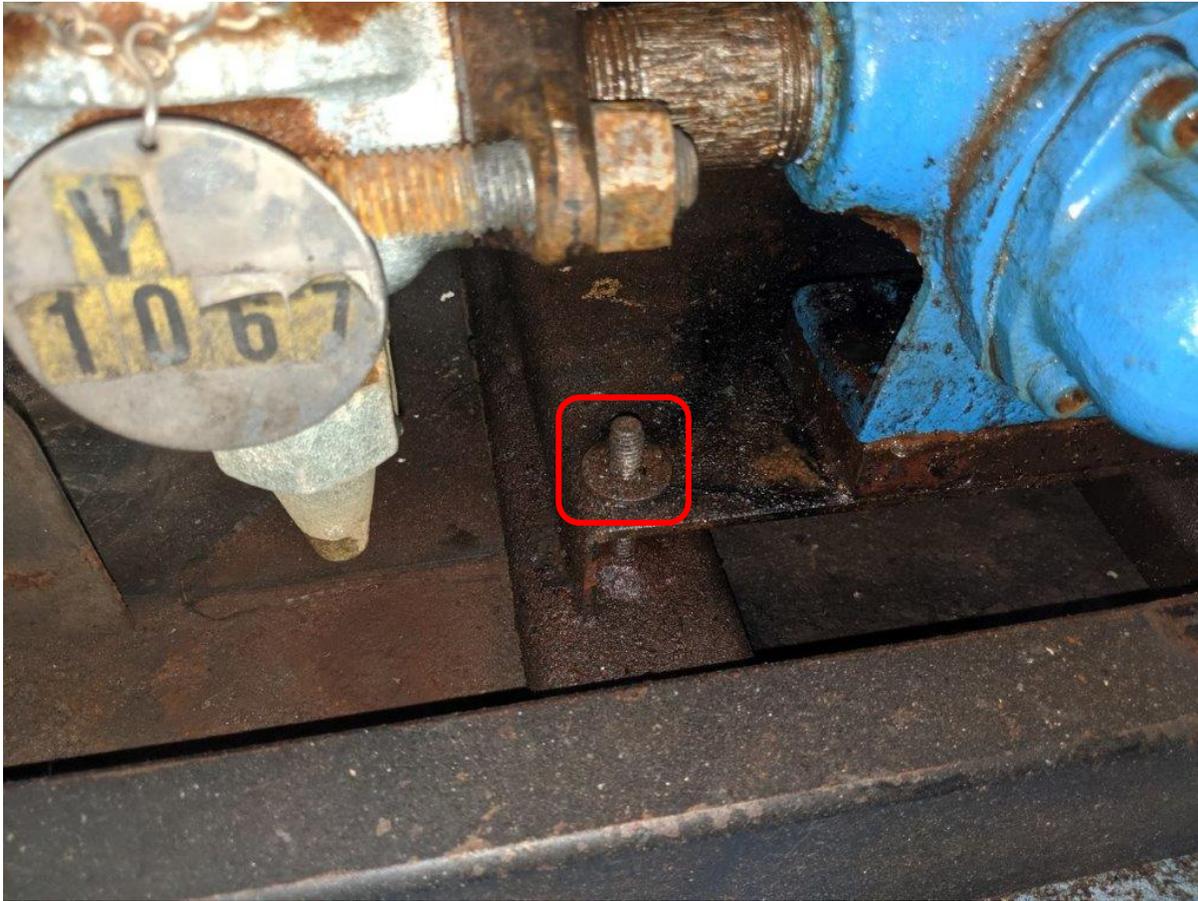
Caption 8. Liquid Transfer Pump Anchorage [[Action Item 2](#)]

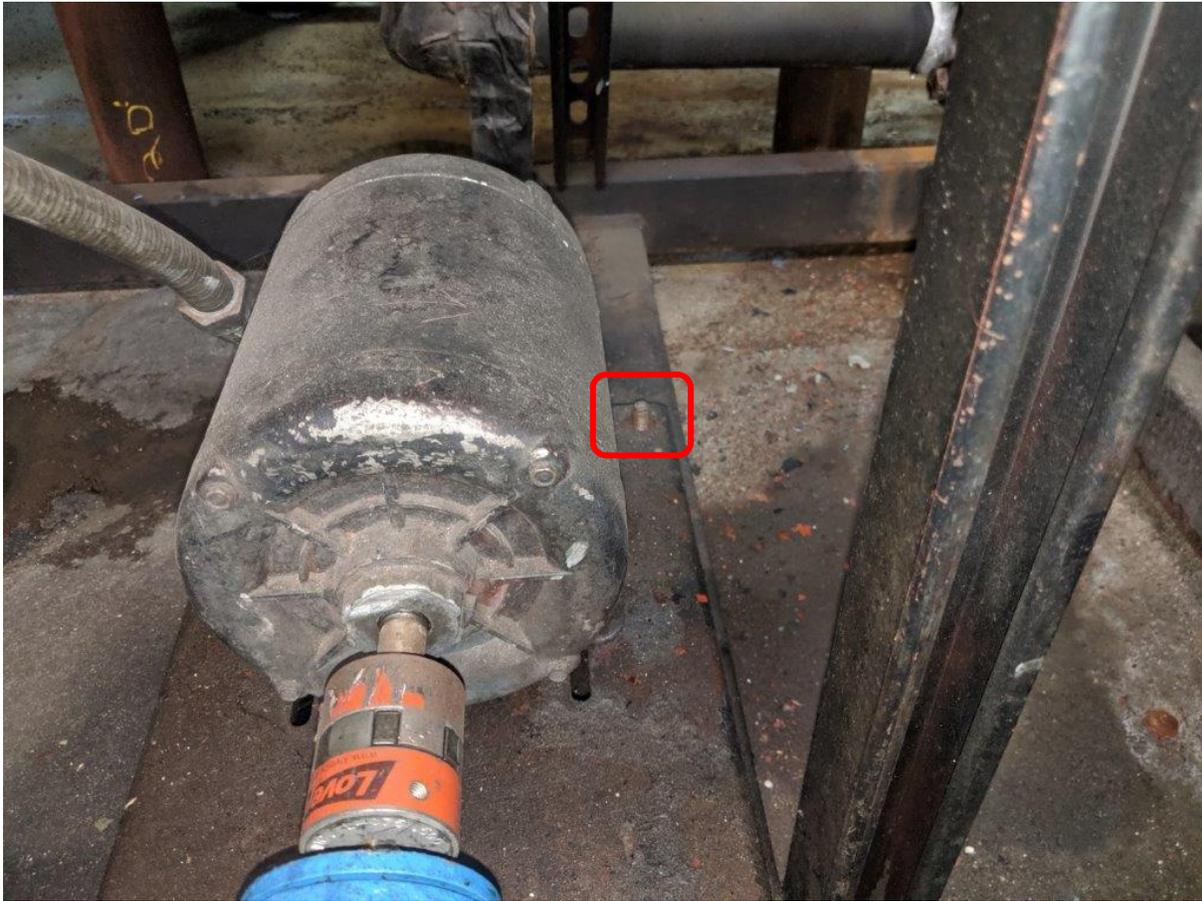
Caption 9. Liquid Transfer Pump Anchorage [[Action Item 2](#)]

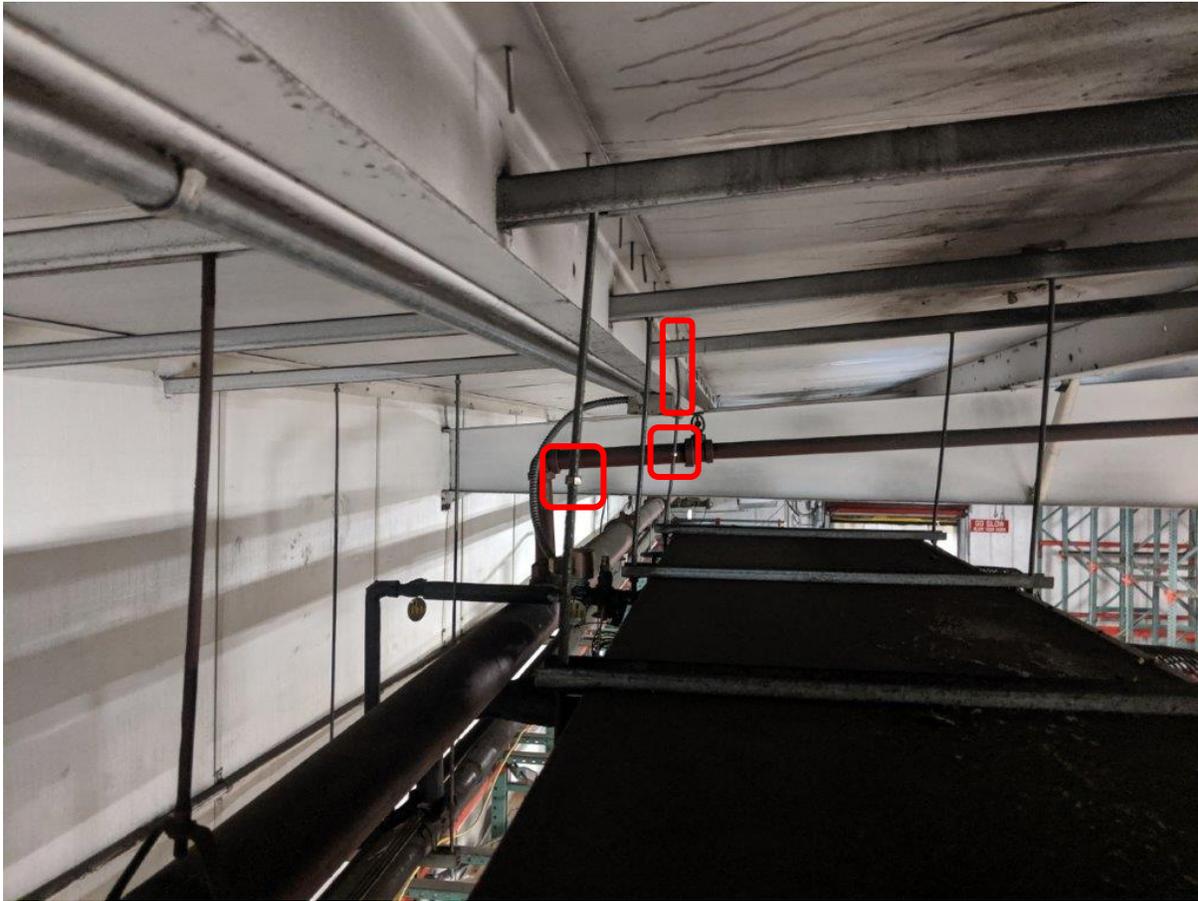
Caption 17. Evaporator EV1 Support Structure [[Action Item 3](#)]

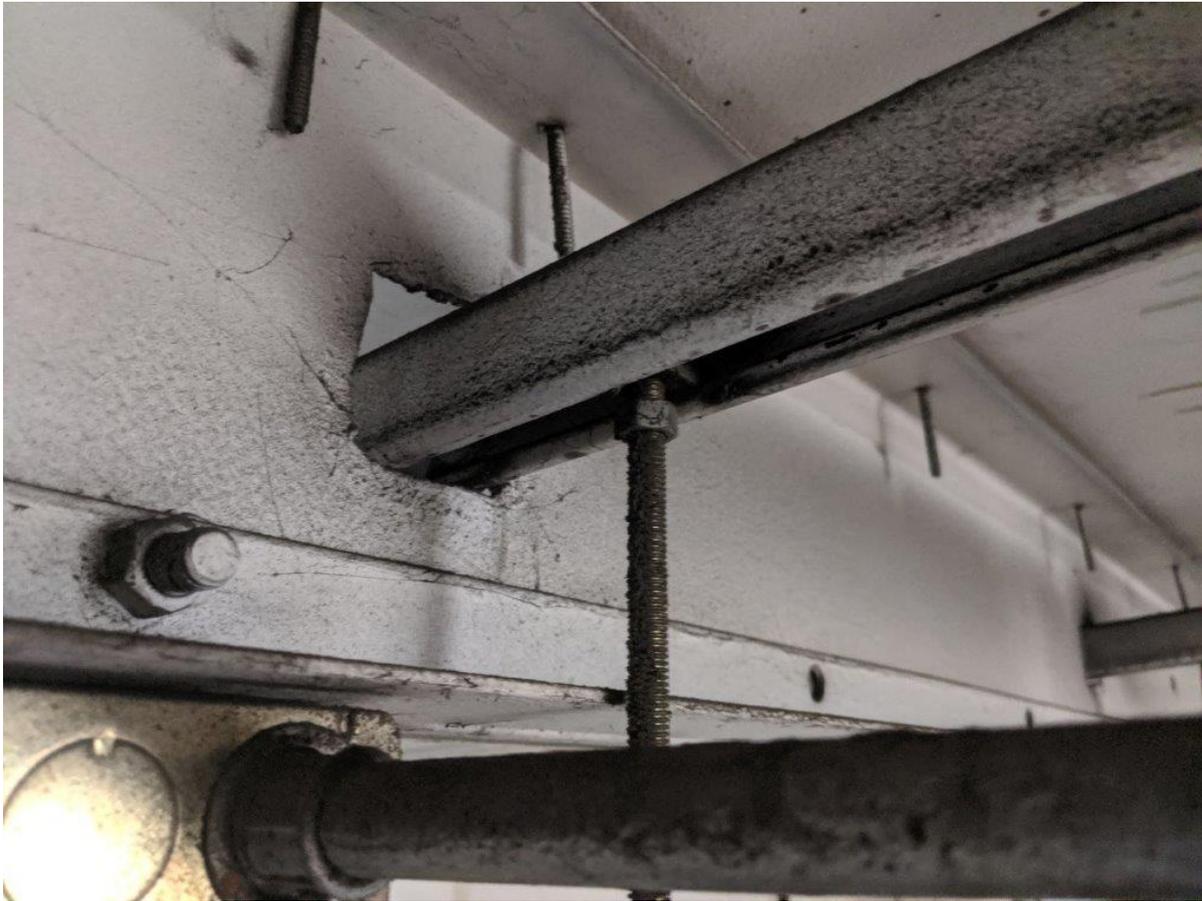
Caption 18. Evaporator EV1 Support Structure [[Action Item 3](#)]

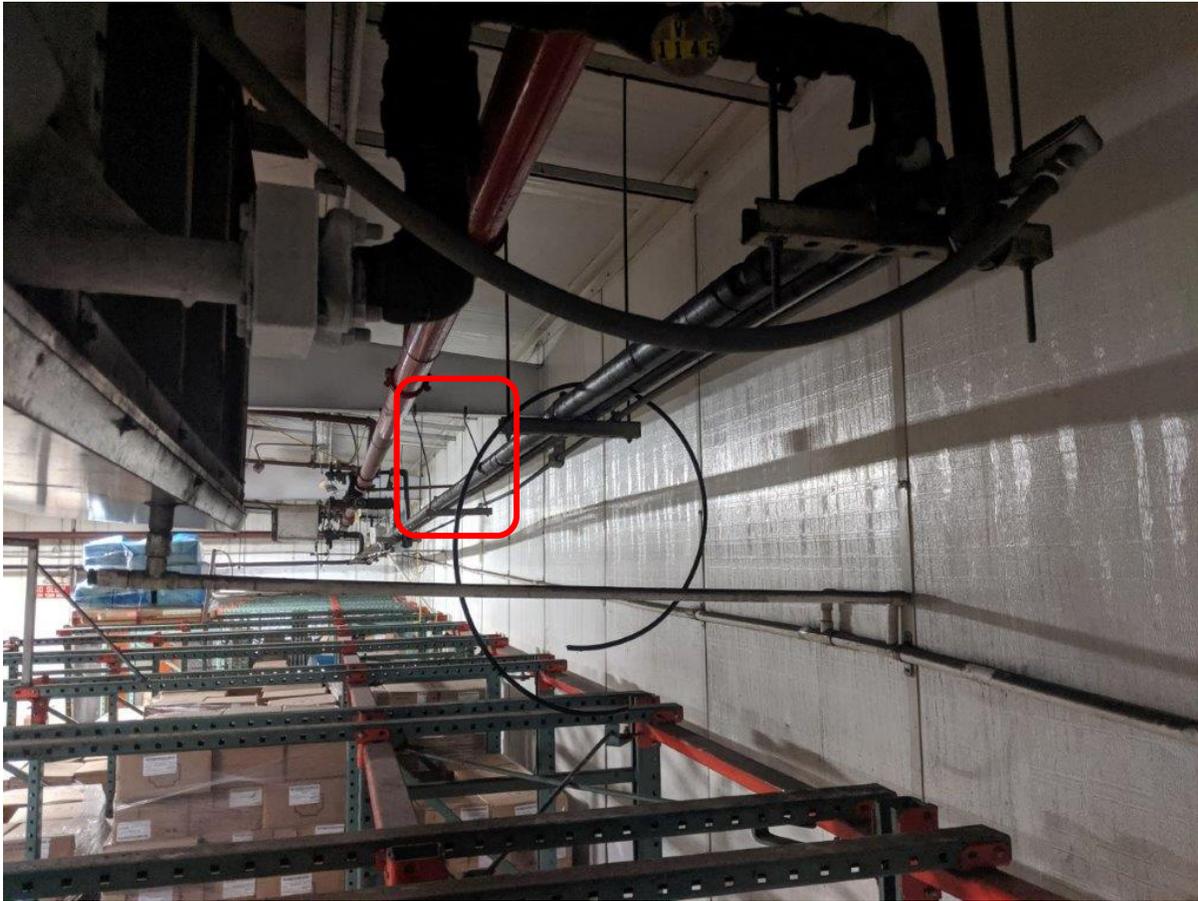
4	Missing sway braces	Install sway braces	1	2019 CalARP Seismic Assessment	4	Cold Box piping	2		Y							Y
5	Detached support	Reattach	1	2019 CalARP Seismic Assessment	5	RV Main Piping on Roof	3		Y							Y
6	Possible missing anchorage of tanks	Verify how the tanks are anchored, install anchors if needed	1	2019 CalARP Seismic Assessment	6	Ice Builders, Diffusion Tanks	2		Y							Y
7	Loose pipe strap	Reinstall pipe strap	1	2019 CalARP Seismic Assessment	7	RV pipe with Ice Builder 1 Surge Drum 2	3		Y							Y
8	Missing sway bracing	Install sway braces	1	2019 CalARP Seismic Assessment	8	Compressors 1-2 LIC	2		Y							Y
9	Supports >7'	Add supports at 7' spacing	1	2019 CalARP Seismic Assessment	9	Fire Diffusion Box	1		Y							Y
10	Pipe not rigidly supported	Secure pipe to HSD or CD pipe	1	2019 CalARP Seismic Assessment	10	Machinery Room Roof	3		Y							Y
11	Not functioning	Fix or replace	2	2020 PHA	1	Auto Purger	3	3/1/2021	N							Y

Caption 22. Cold Box Piping [[Action Item 4](#)]

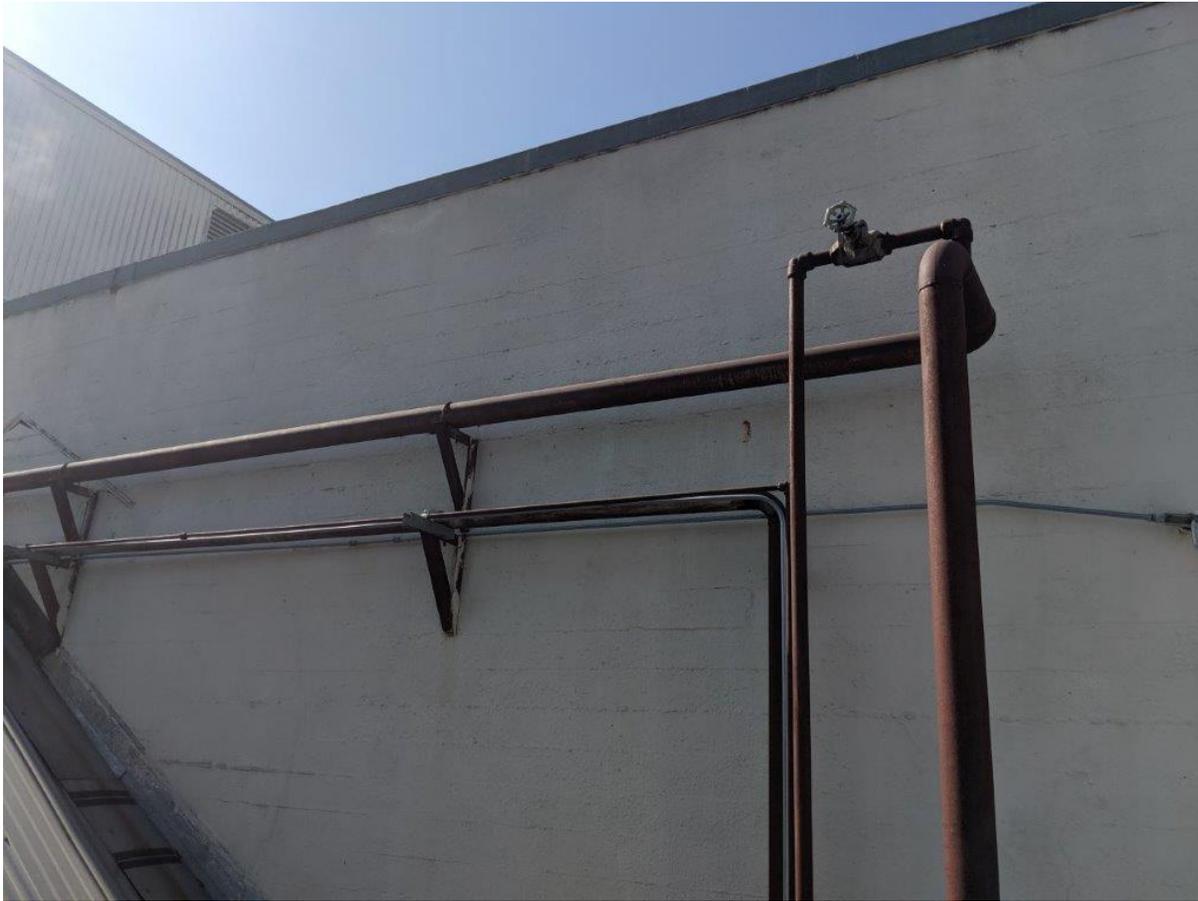
Caption 23. Roof Piping [[Action Item 10](#)]

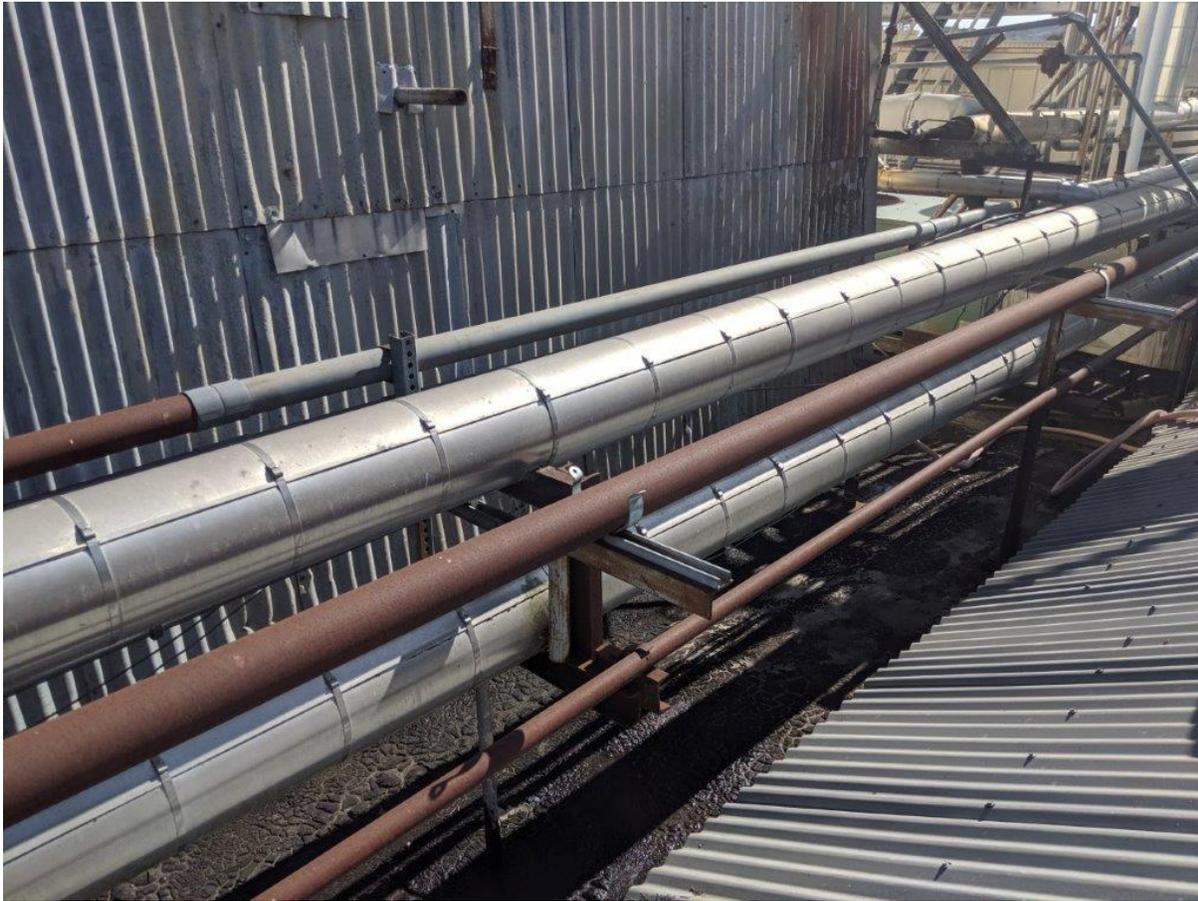
Caption 25. Roof Piping [[Action Item 5](#)]

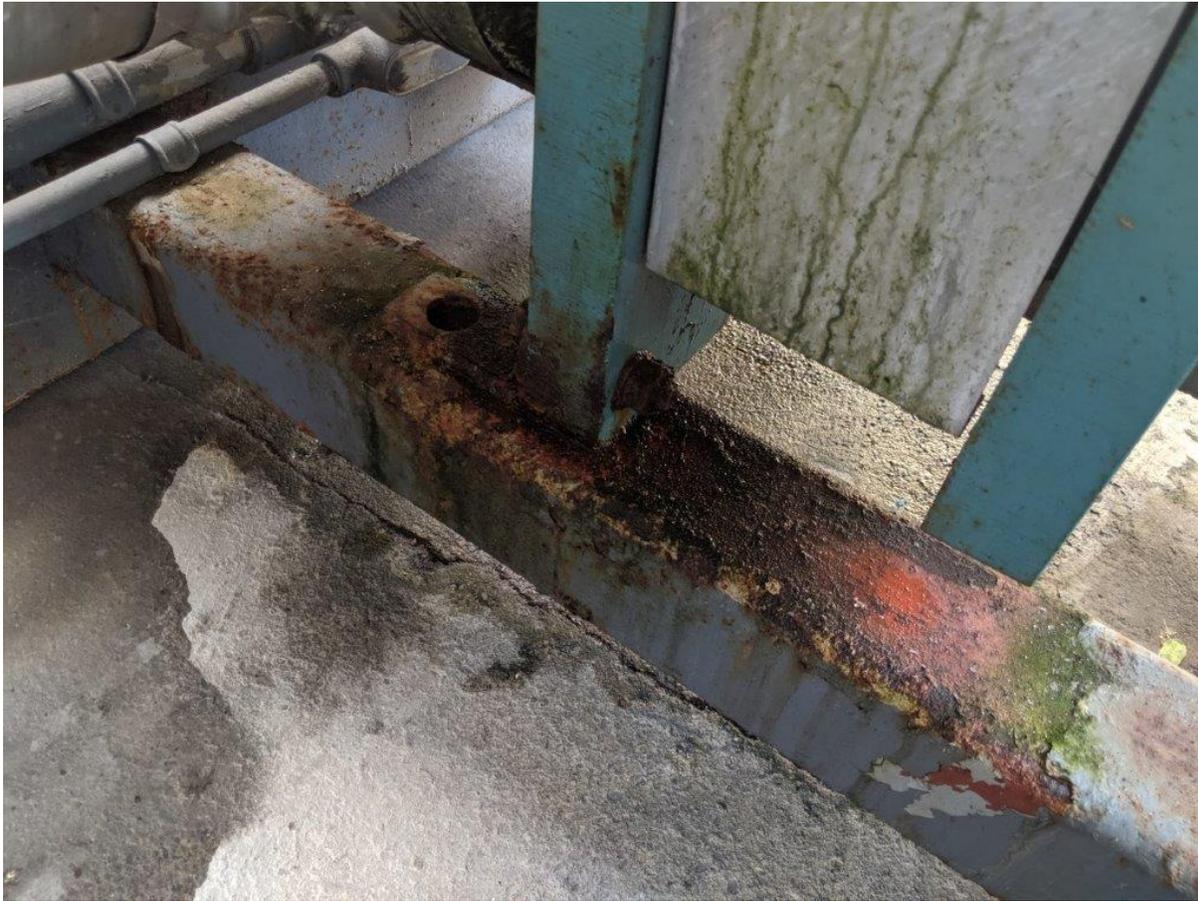
Caption 30. Glycol Chiller Anchorage to Skid [[Action Item 1](#)]

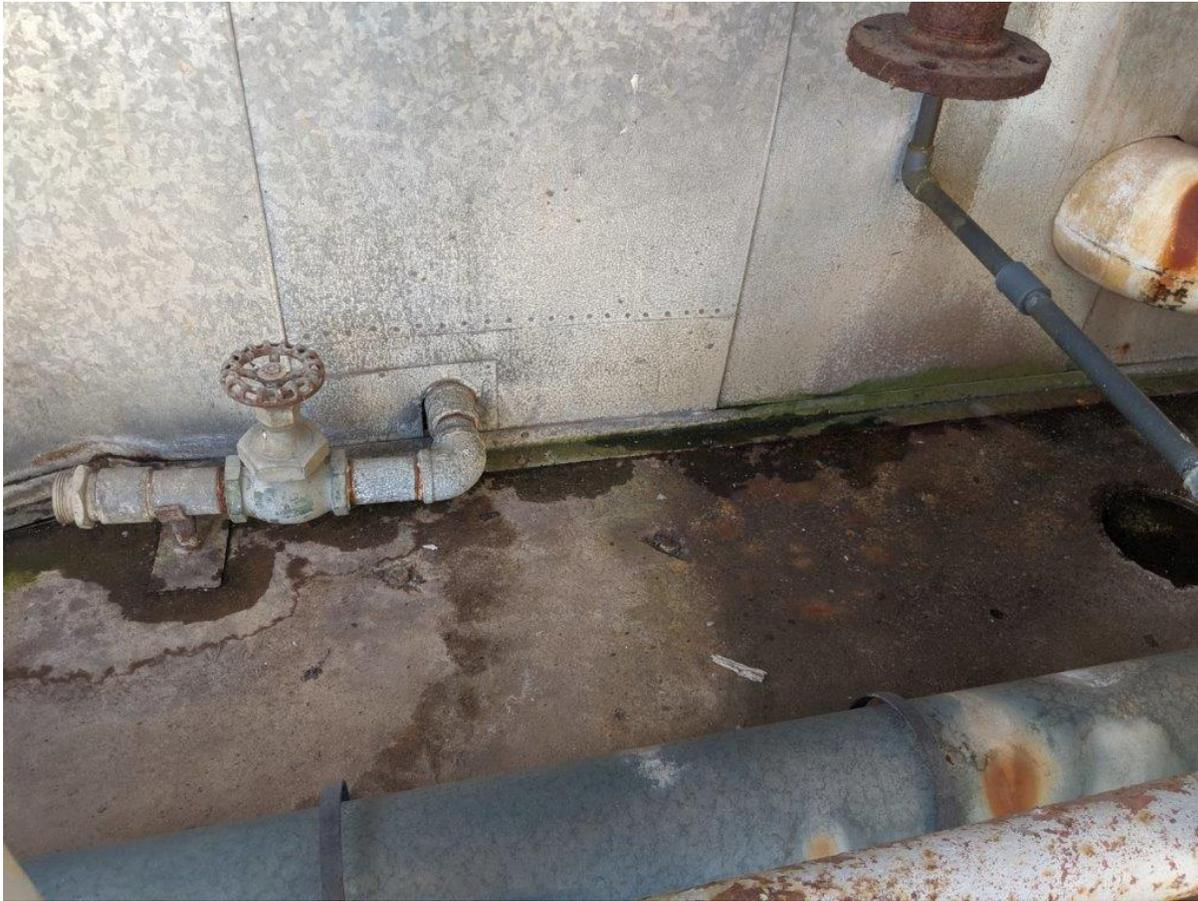
Caption 31. Ice Builder 1 [[Action Item 6](#)]

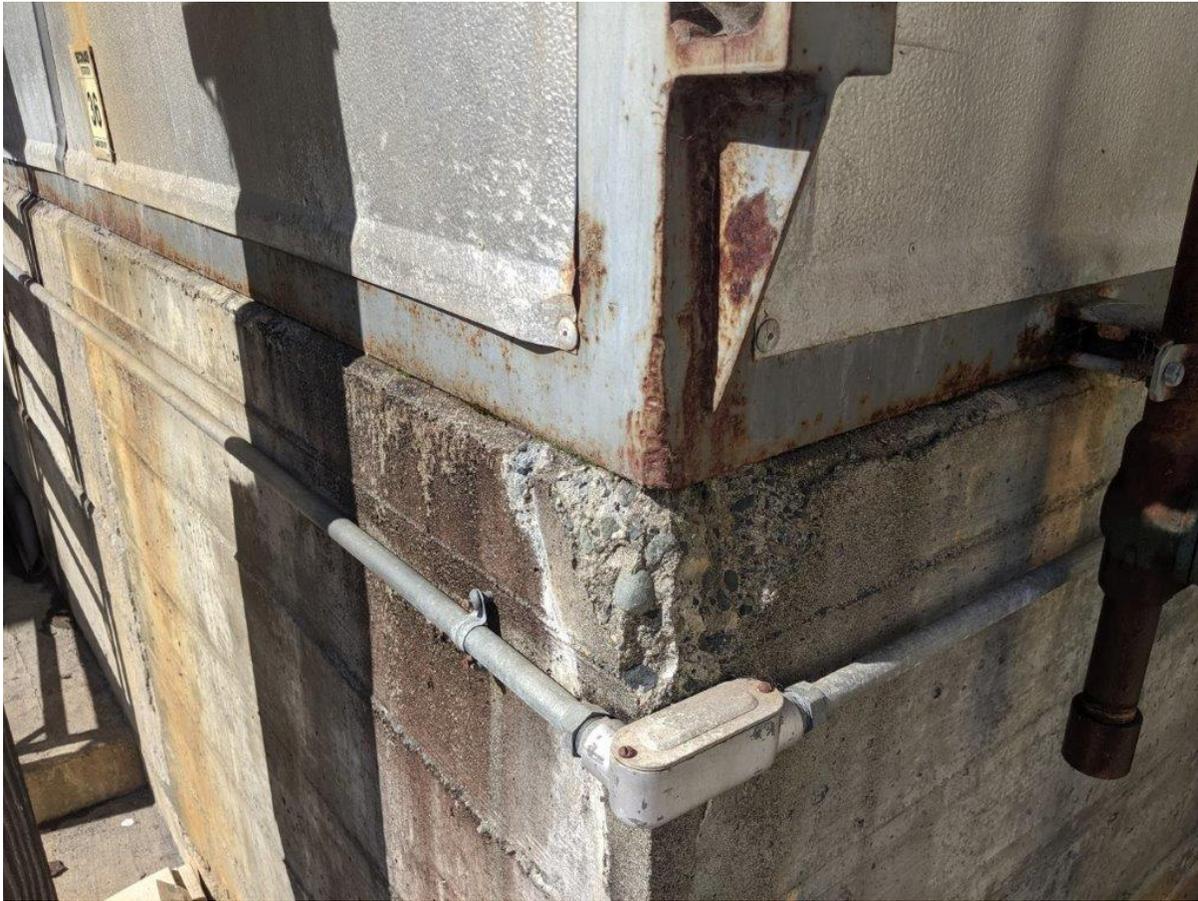
Caption 34. Ice Builder 2 [[Action Item 6](#)]

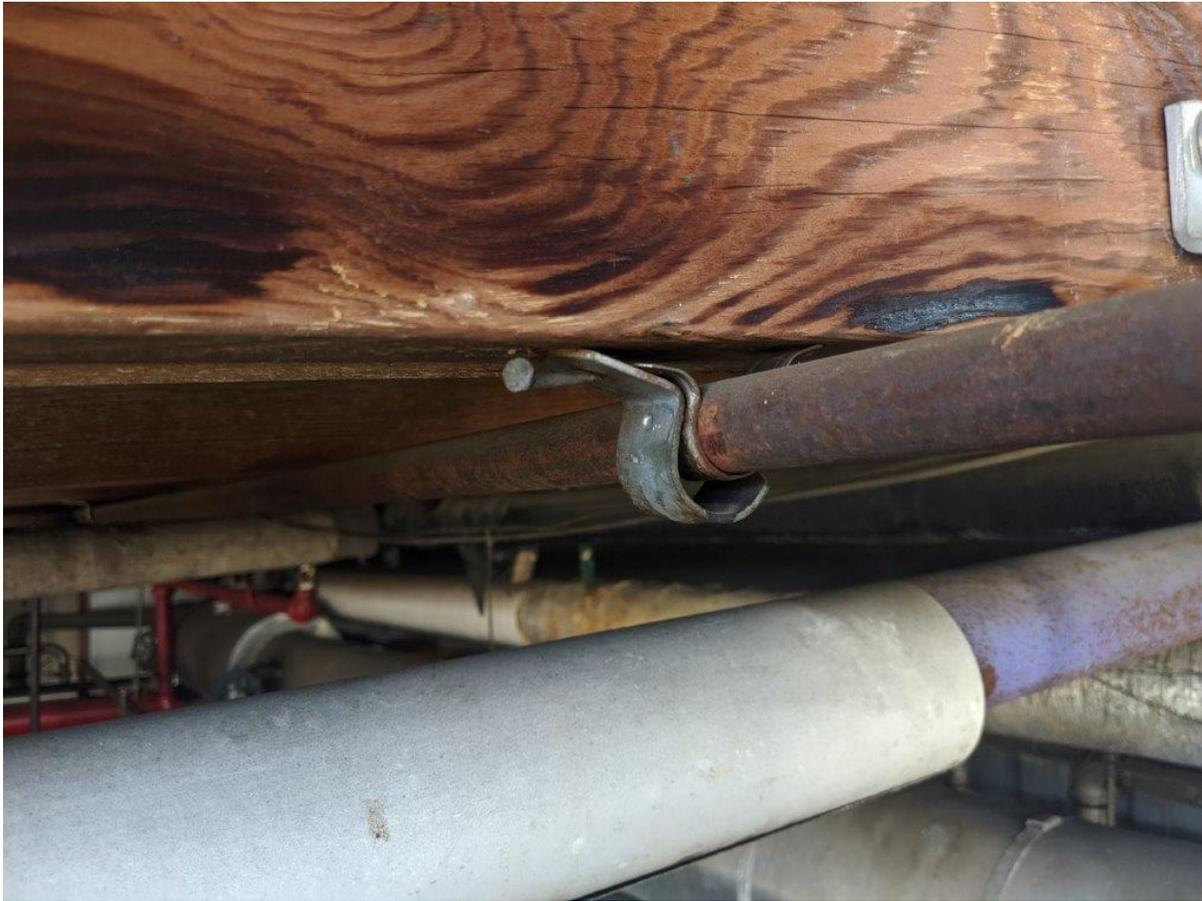
Caption 36. Ice Builder 1 Surge Drum 2 RV Pipe Fastener [[Action Item 7](#)]

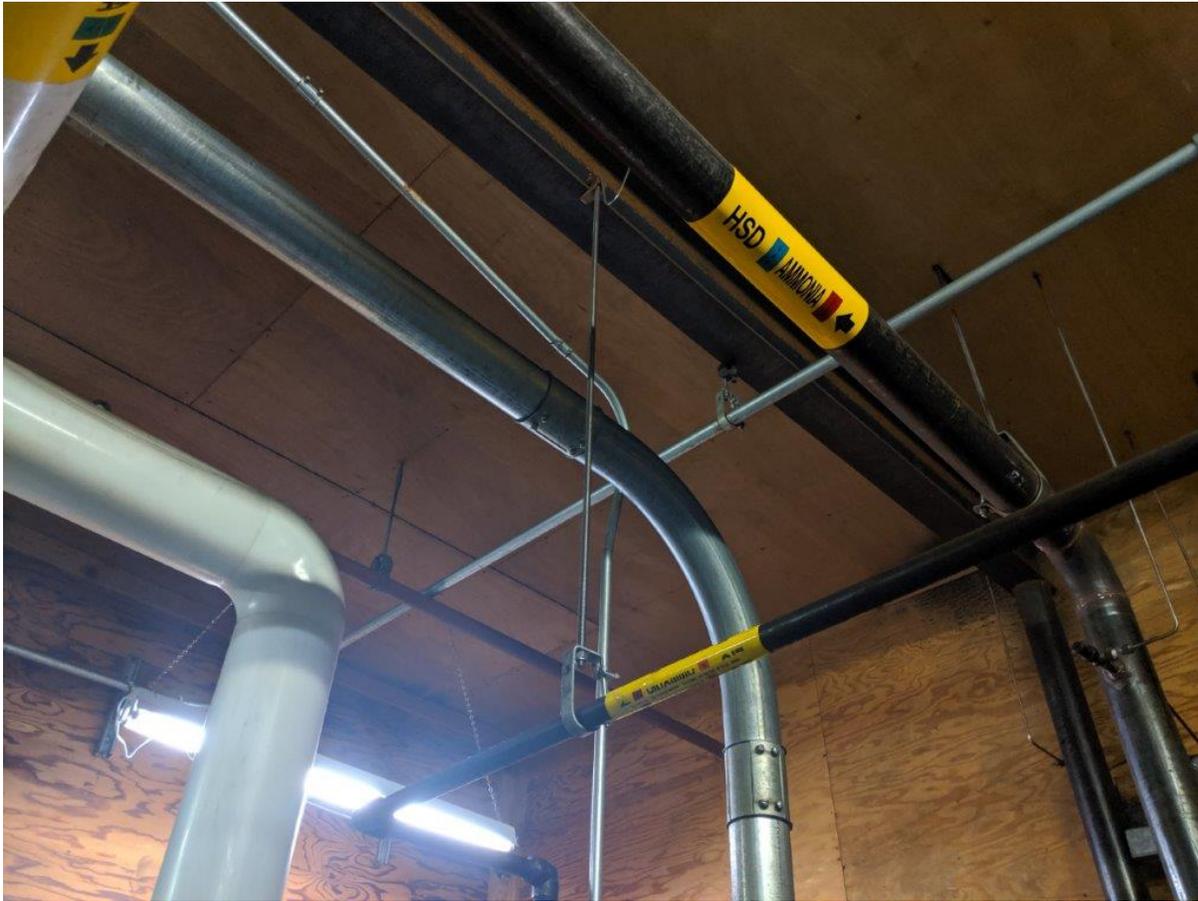
Caption 38. Compressor 1 LIC Pipe [\[Action Item 8\]](#)

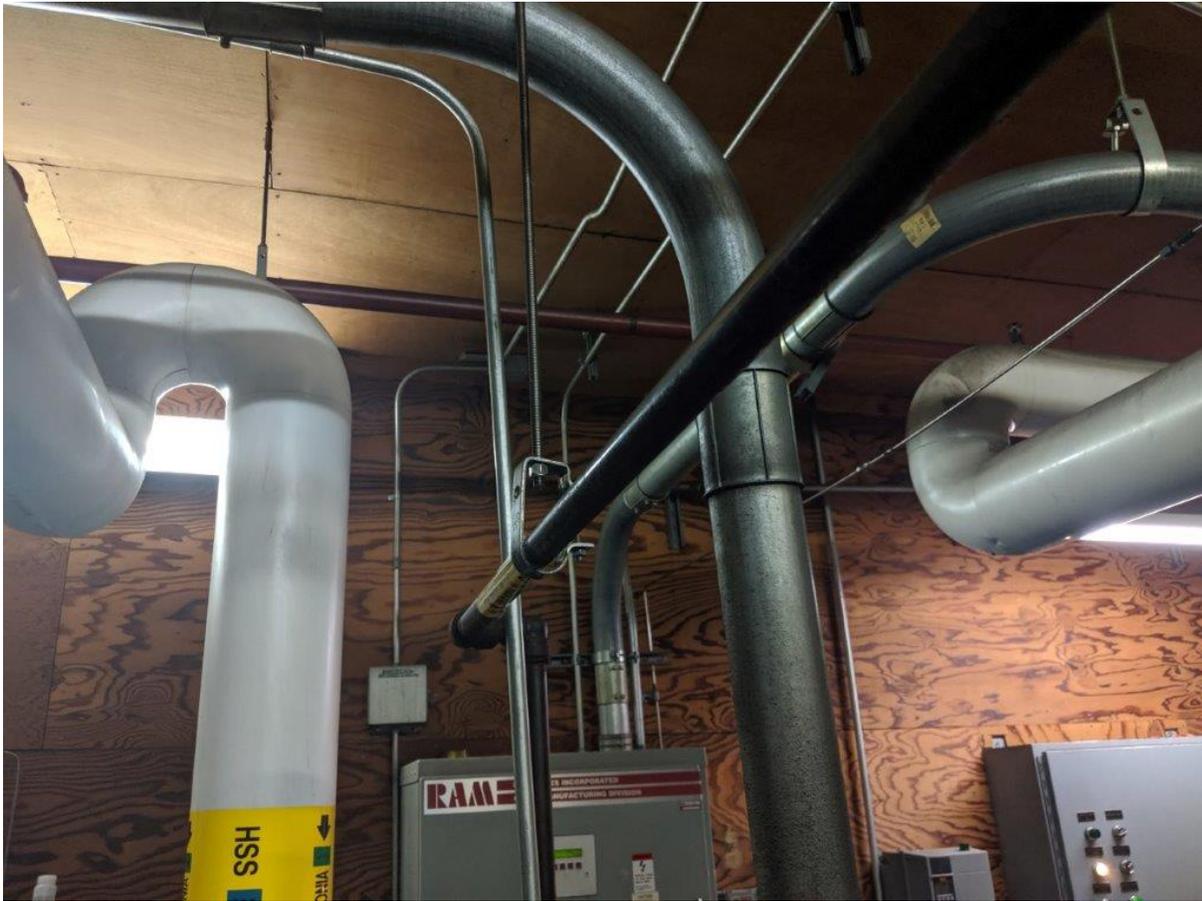
Caption 39. Compressor 2 LIC Pipe [\[Action Item 8\]](#)

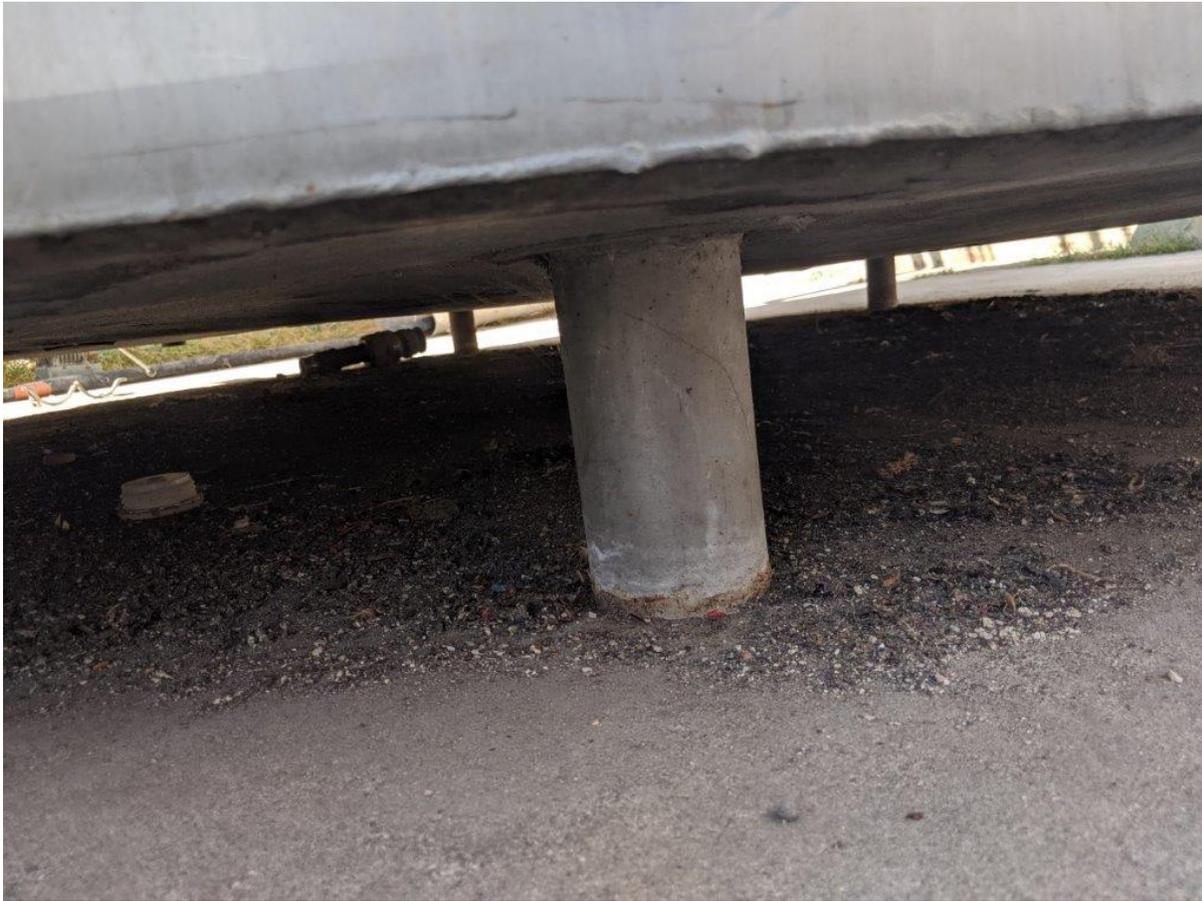
Caption 41. Ammonia Diffusion Tank Anchorage (Typical) [[Action Item 6](#)]

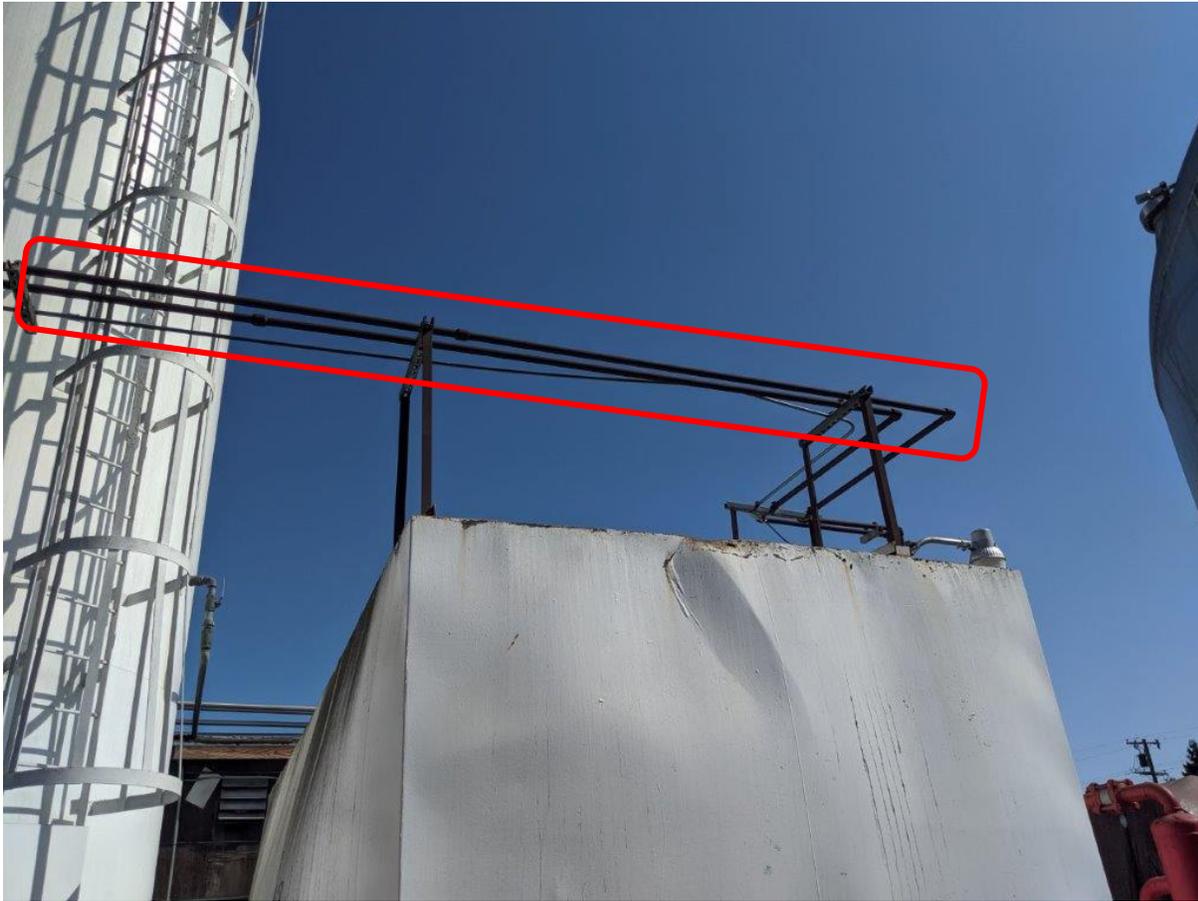
Caption 42. Fire Diffusion Box Piping [[Action Item 9](#)]

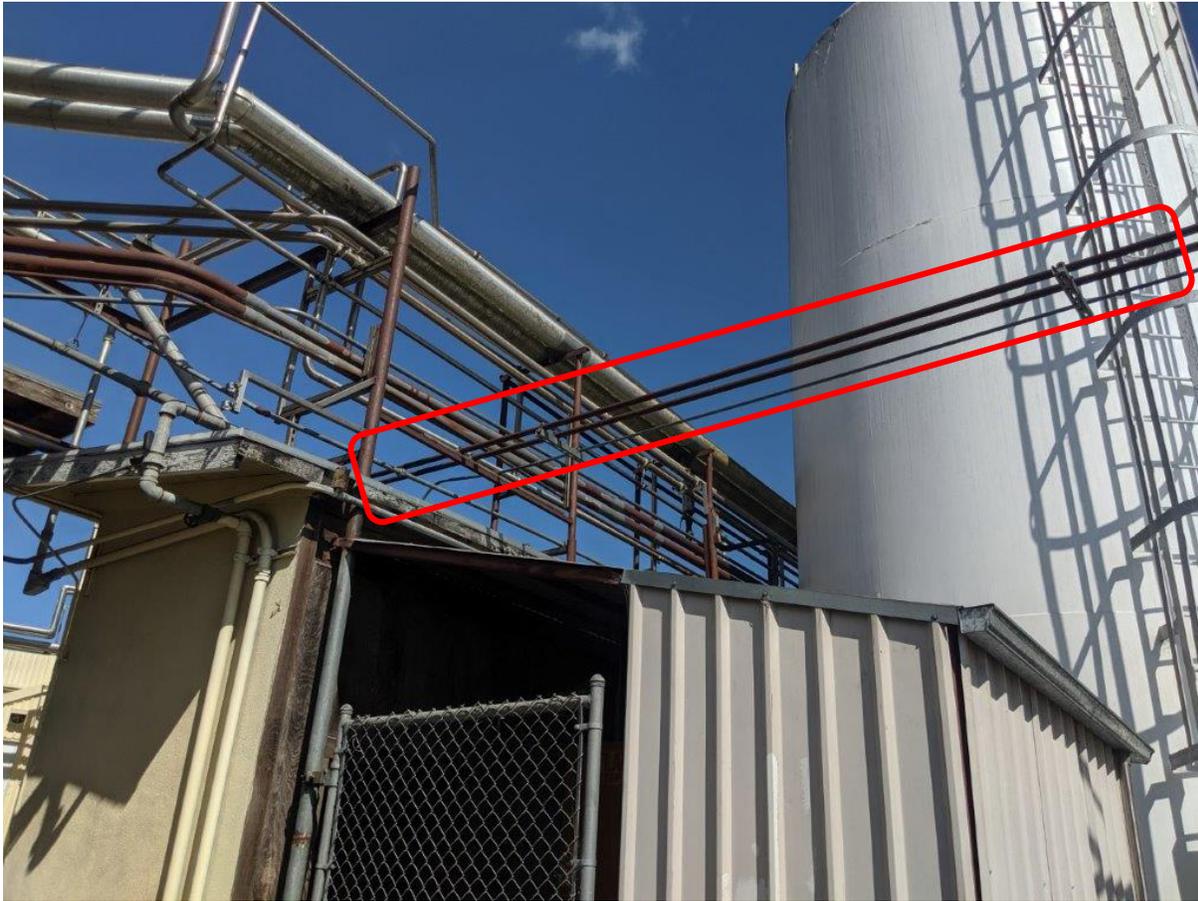
Caption 43. Fire Diffusion Box Piping [[Action Item 9](#)]
