## **TECHNICAL MEMORANDUM**

SUBJECT: Technical Support Services, Haystack Landing  
215 Weller, and 15 and 19 Copeland Streets  
Petaluma, California

Project No.: 702-17-16-28  
SENT VIA: EMAIL

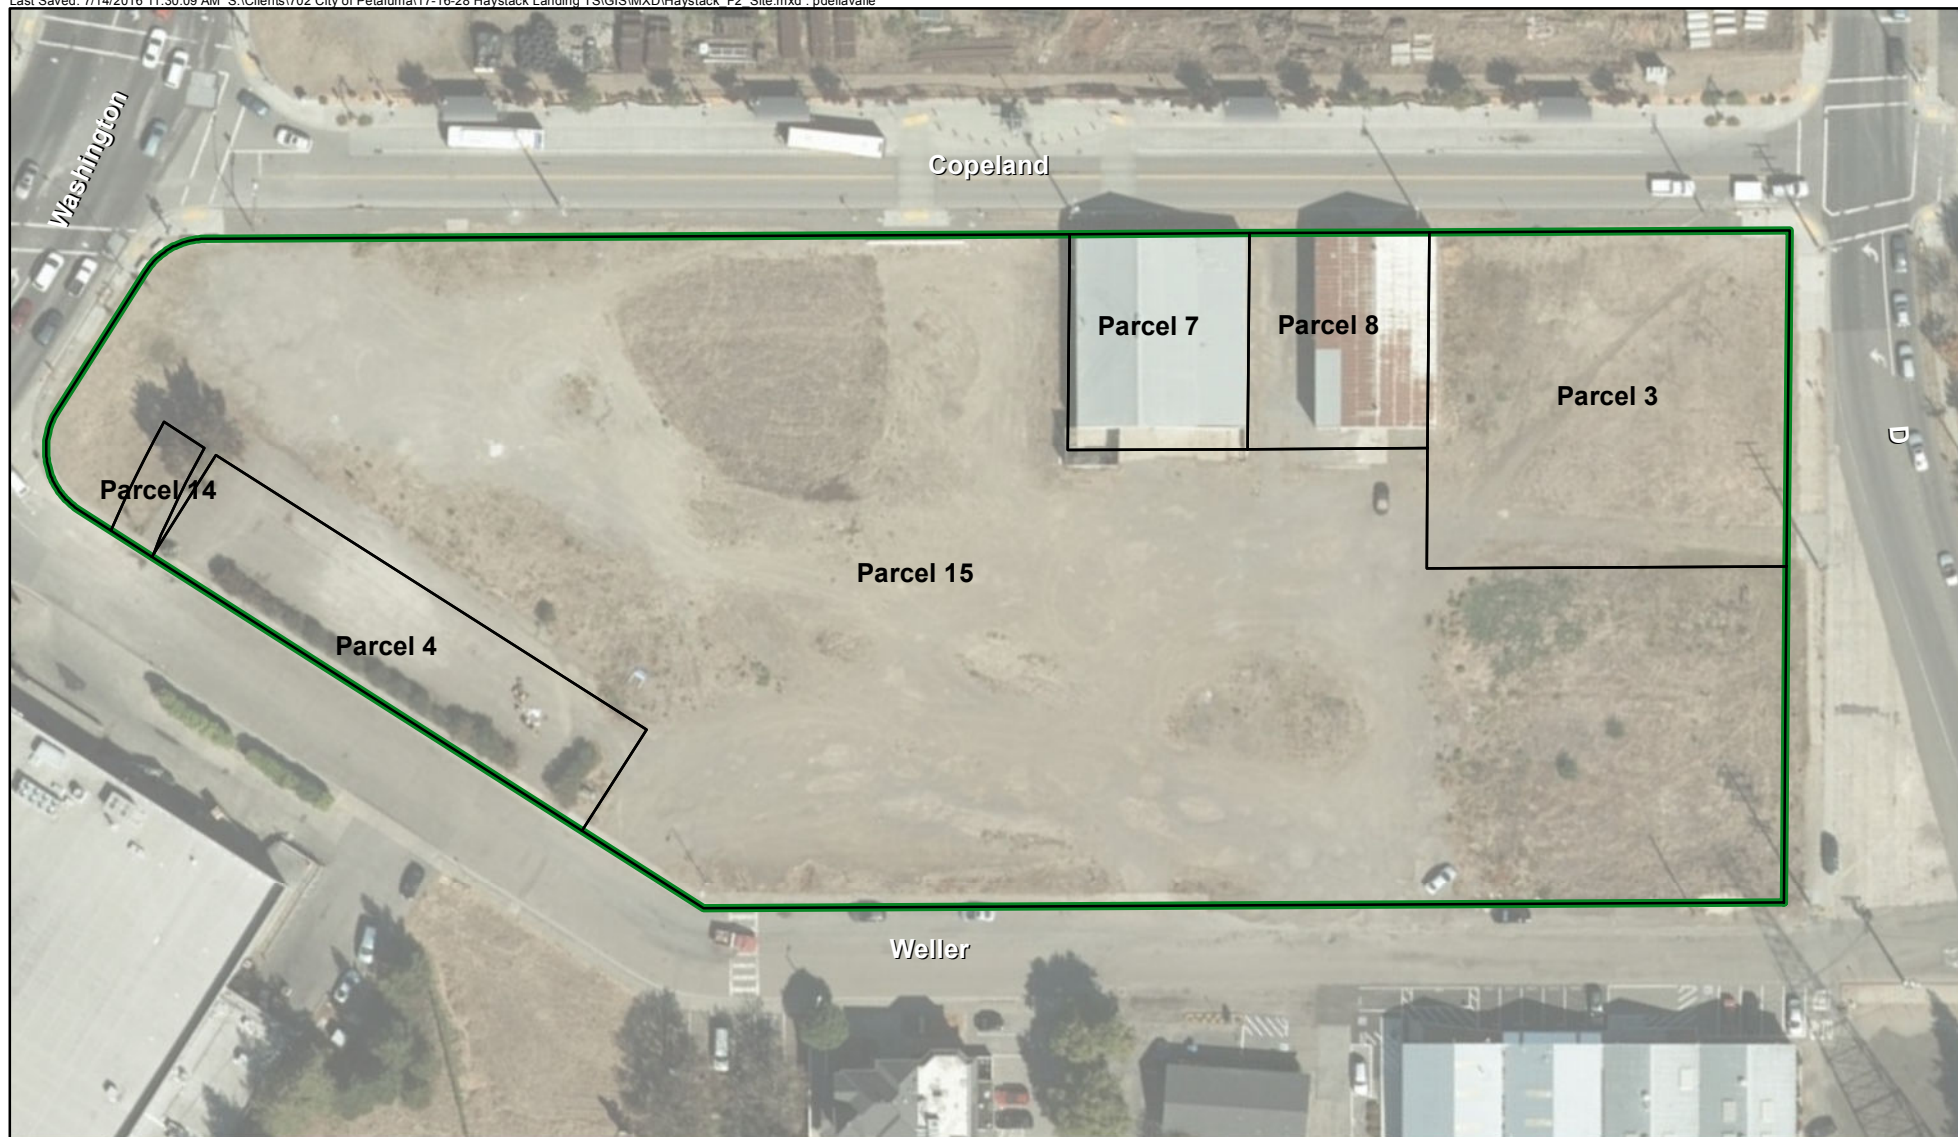
**Figure 2**  
**Site Map**

The Project Site property (hereafter referred to as the Site) is known locally as Haystack Landing and is located one block north of the Petaluma River near downtown Petaluma, California (Figure 1). The current Site addresses include 215 Weller Street, 15 Copeland Street, and 19 Copeland Street. The former addresses included 17 Copeland Street. The Site is bounded on the north by Copeland Street, on the west by East Washington Street, on the south by Weller Street and on the east by East D Street. The Site consists of six parcels (Figure 2); Assessor's Parcel Numbers:

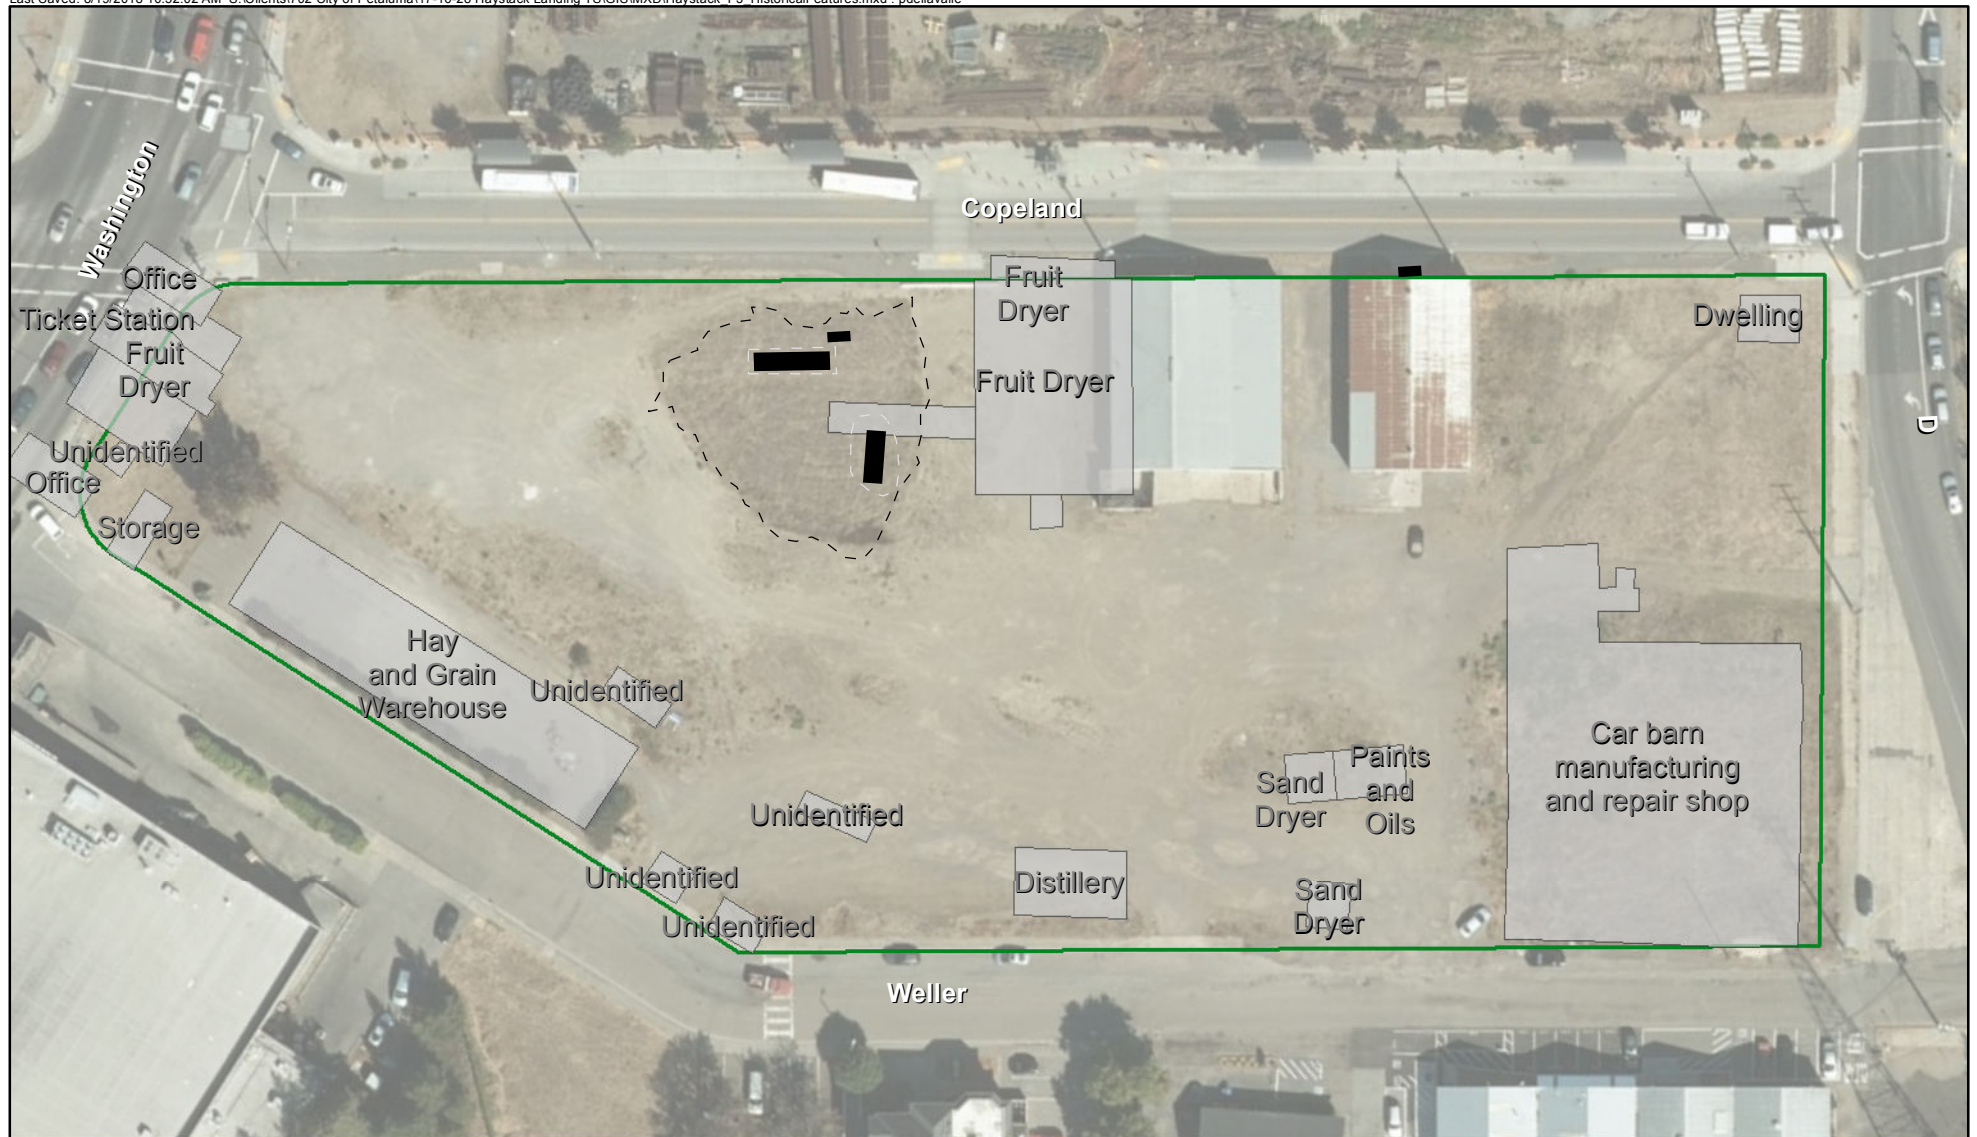
**Figure 3**

- Former Building Footprint
- Former Underground Storage Tank
- Excavation in 1990
- Excavation in 2009
- Project Boundary

### Historical Features

The Site has been used for commercial and industrial purposes since at least 1885. Early uses included storage of hay and lumber, a fruit dryer, and a distillery. Historical Site features are shown on Figure 3. By 1906 Parcel 15, the largest Site parcel, had been acquired by the Petaluma and Santa Rosa Railway and used as a rail yard, including a ticket office and a car repair barn. The Railway ceased operations in the late 1940s. The ticket office was moved from the Site in the 1990s and the car barn was destroyed by fire in 2001. In the 1960s Bar Ale Inc. leased Parcel 15 from the Railway and installed fuel underground storage tanks (UST) for its fleet of delivery trucks. Bar Ale Inc. operated out of Parcel 15 into the 1990s. A building was constructed on

Residual concentrations of petroleum hydrocarbons exist in the soil because of leaks from three fuel USTs installed in the 1960s by Bar Ale Inc. The tanks were located on Parcel 15, south of Copeland Street and west of Parcel 7 (Figure 3). The tanks included a 12,000-gallon diesel tank, an

Historical records indicate other possible sources of petroleum hydrocarbons in soil at the Site. In the late 1800s and early 1900s, furnaces were employed by three former fruit drying operations and a boiler was used by a former distillery at the Site (Figure 3). The sources do not identify the type of fuel used to ignite the furnaces and boiler or the methods or locations where the fuel was stored. Fuel types may have included wood, coal, fuel oil, and, after 1900, natural gas. Another possible source of petroleum hydrocarbons is an above ground fuel oil tank which was used by the Petaluma and Santa Rosa Railway to fuel locomotives from the late 1940s to the early 1960s. The exact location of the former tank is not documented; however, it was most likely in one of two locations: at or near the southern sand dryer adjacent to Weller Street or between the northern sand dryer and the former car barn.

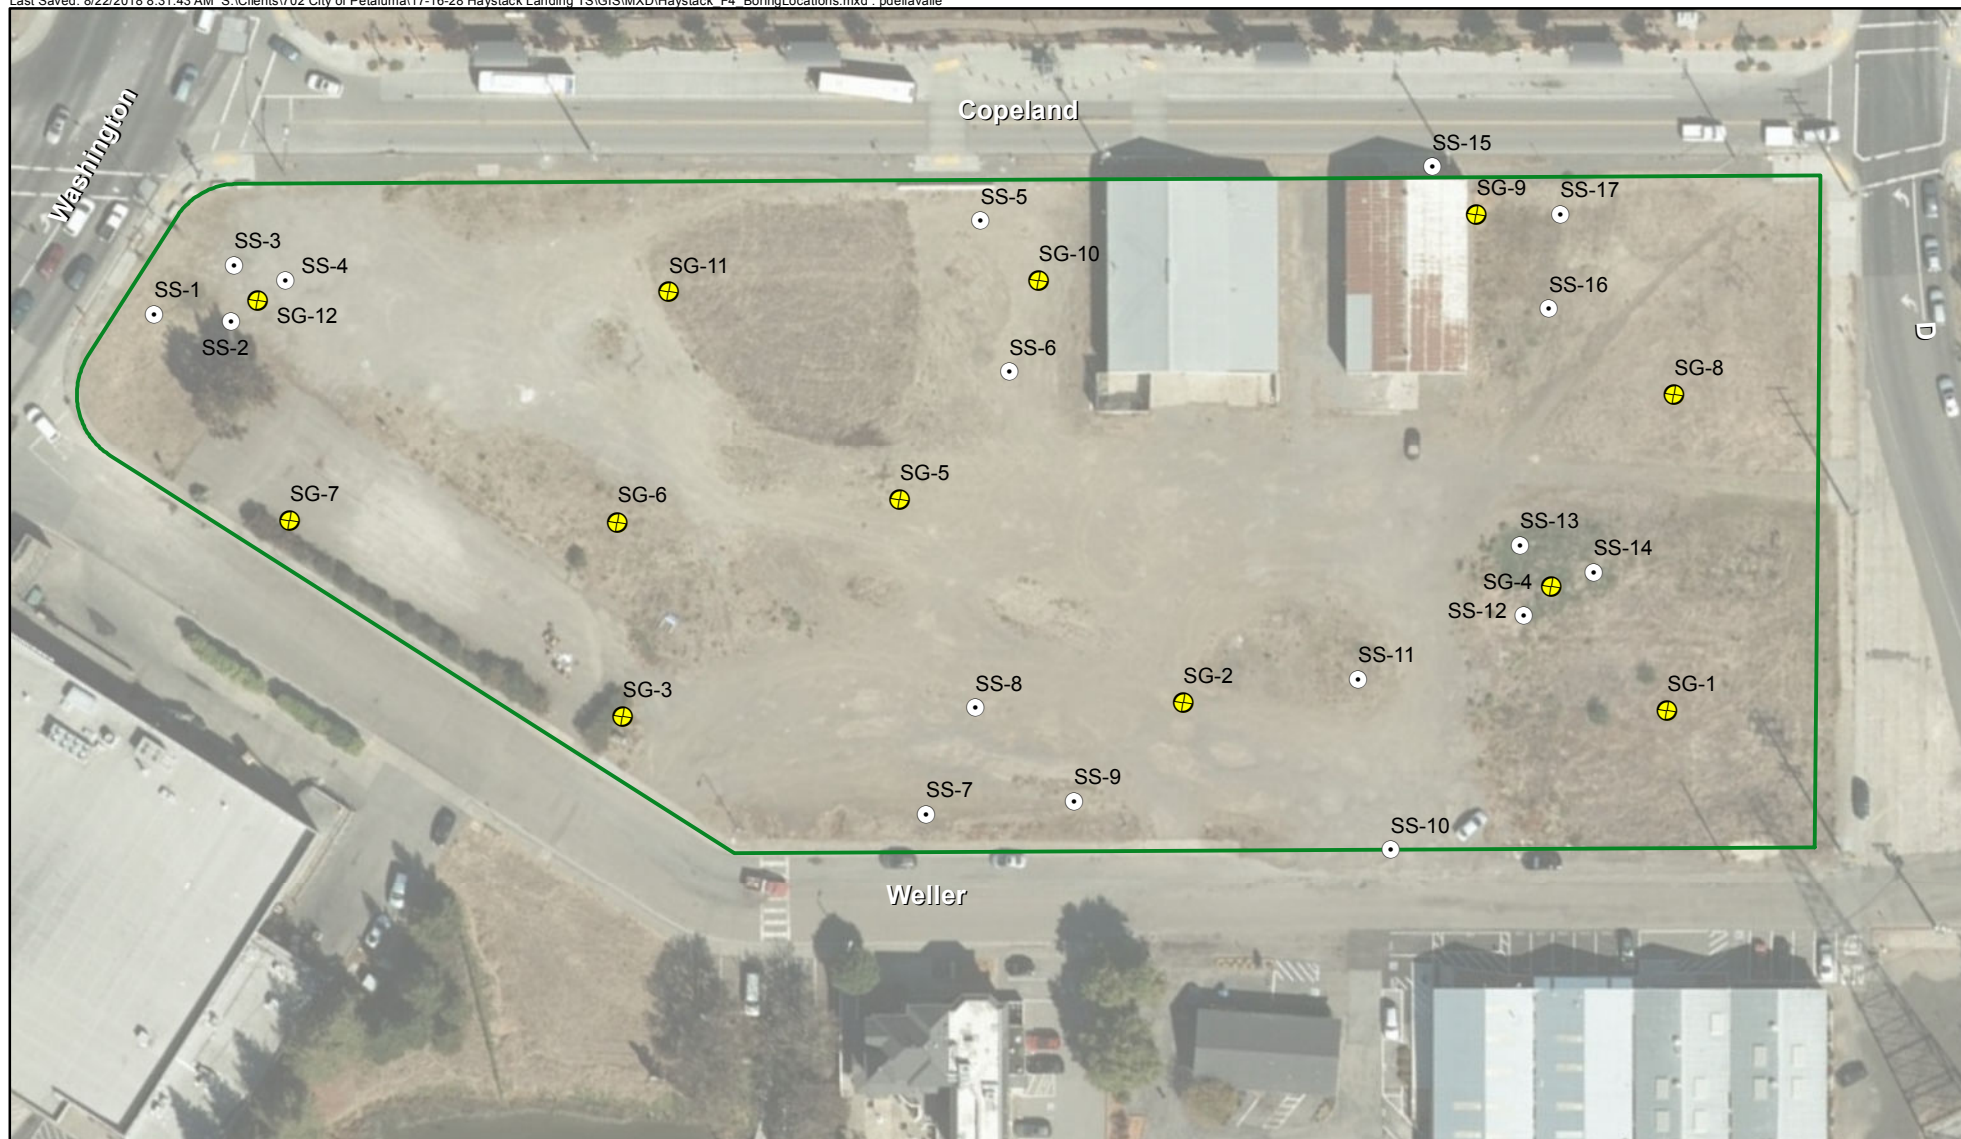
**Figure 4**  
**Environmental**  
**Boring Locations**

Boring Location - 2005 ENVIRON Investigation
-

Boring Location - 2013 ECON Investigation
-

Concentrations of antimony, arsenic, cadmium, lead, vanadium, and mercury exceeding the San Francisco Bay RWQCB's Environmental Screening Levels (ESL) for residential uses (RWQCB, 2007 ESLs) were detected in shallow soil at the Site by the 2005 ENVIRON investigation. The results are summarized on Table 1 and the sample locations are shown on Figure 4. Environ collected 36 samples from three depths at 12 locations; near surface (0 to 6-inches), 2.5 to 3 fbg, and 4.5 to 5 fbg.
