Project Information:	Project Scope:	Contacts:
The Creamery	Ammonia Refrigeration System:	Fernando Ortiz - Plant manager
621 Western Ave.	2019 CalARP Seismic Assessment	Larry Peter - owner
Petaluma, CA 94952	2015 Hazard Review - PHA	George Bennett MPE Services (951) 735-4418 georgeb@mpeservicesinc.com
(707) 762-3446	2020 Hazard Review - PHA	
Contact:

Ammonia Refrigeration System CalARP Seismic Assessment

5-Year Hazard Review of the Ammonia Refrigeration System

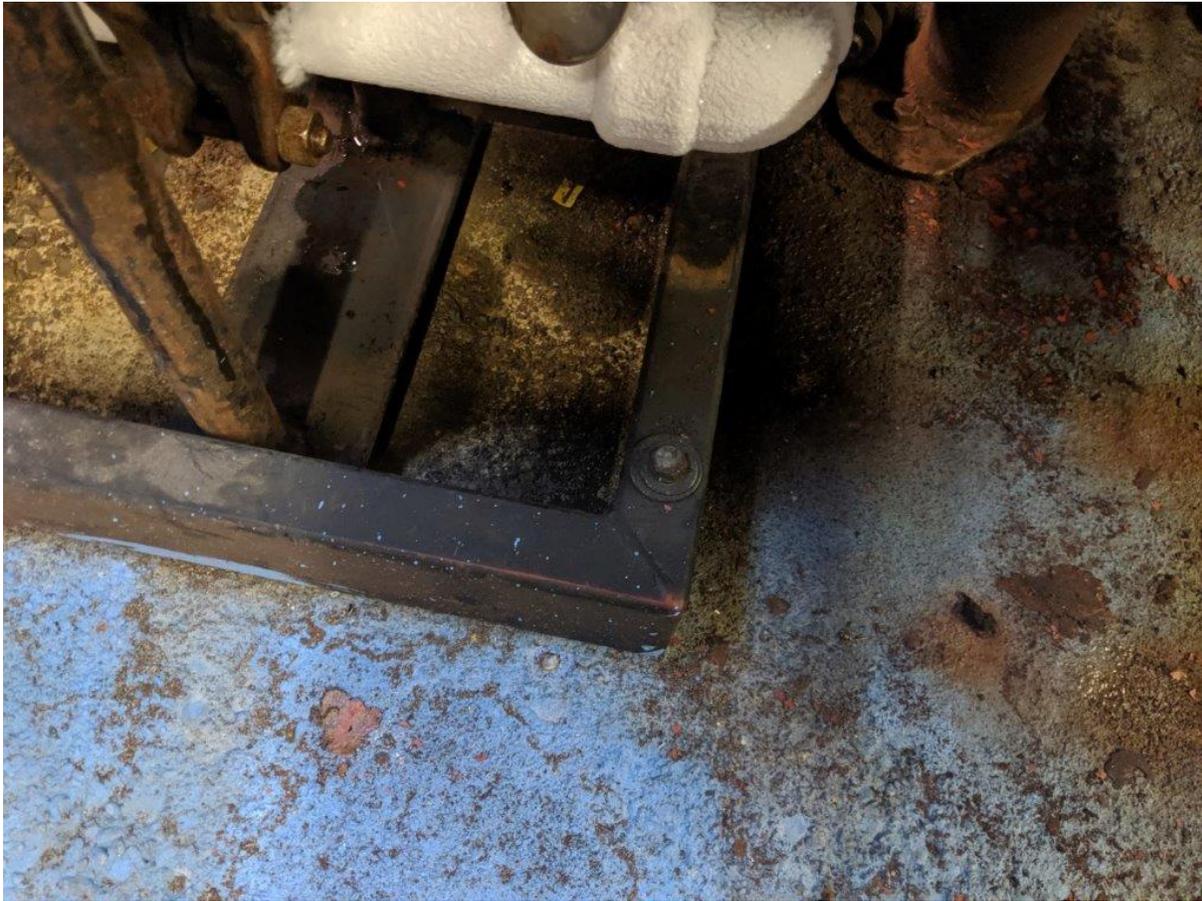
Caption 7. Liquid Transfer Skid Anchorage (Typical)

Most ammonia refrigeration equipment is properly anchored in accordance with ASCE/SEI 7-2010 §13.4. Notable exceptions of equipment not properly anchored include the Liquid Transfer Pump and Evaporator EV1. The Liquid Transfer Pump anchor nuts are missing entirely and Evaporator EV1 supporting rods are bent and have multiple loose nuts. It is unknown if the Ice Builders are anchored to the concrete as no anchor nuts/bolts were visible. Similarly, it could not be confirmed if the Diffusion Tanks are anchored to the concrete. The Diffusion Tanks are configured with short pipe stubs which rest on the bottom of the tanks, but it is unclear if the pipes are embedded into the concrete beneath.

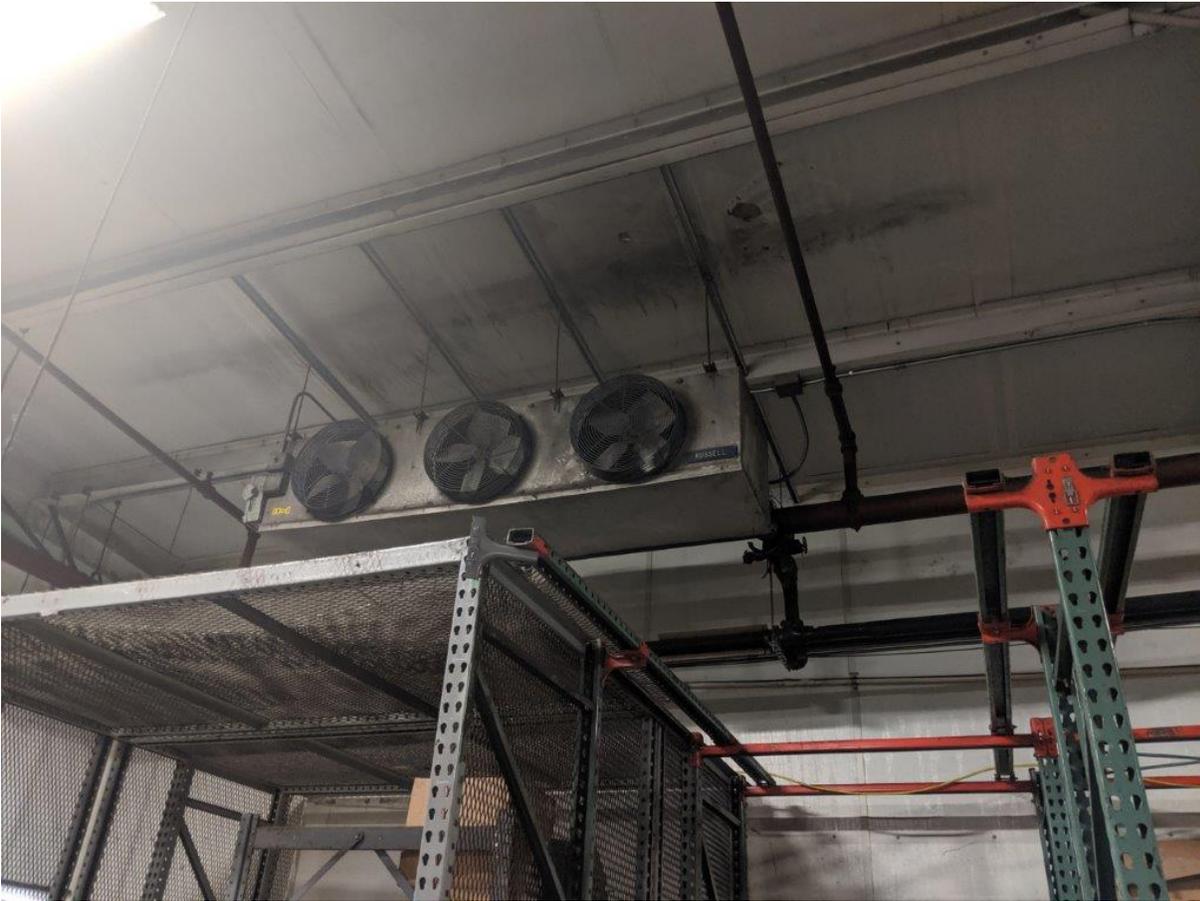
Caption 16. Evaporator EV1

3	Evaporator EV1	The condition of the Evaporator EV1 supports are a concern. Several anchor nuts are loose and one of the rear all-threads are bent [Caption 17, Caption 18]. Additionally, the unit is not configured with sway bracing to restrict lateral/longitudinal movement. It is recommended that the all nuts be properly tightened, bent all-thread replaced, and sway braces installed. [ASHRAE Practical Guide to Seismic Restraint Second Edition Page 131]	1				
4	Cold Box Piping	The pipes in the Cold Box are supported by trapeze pipe supports. The supports are not equipped with sway braces to restrict lateral or longitudinal movement [Caption 20]. In regard to sway bracing of suspended piping, ASHRAE Practical Guide to Seismic Restraint Second Edition Page 98 requires that "each individual or trapeze-supported piping run should be sway braced to limit motion in all directions." Additionally, the all-thread rods associated with one of the trapeze supports between Evaporators EV1 and EV2 are bent [Caption 22]. It is recommended that the bent rods be replaced, and sway bracing installed for expected seismic activity. [ASHRAE Practical Guide to Seismic Restraint Second Edition Page 98]	2

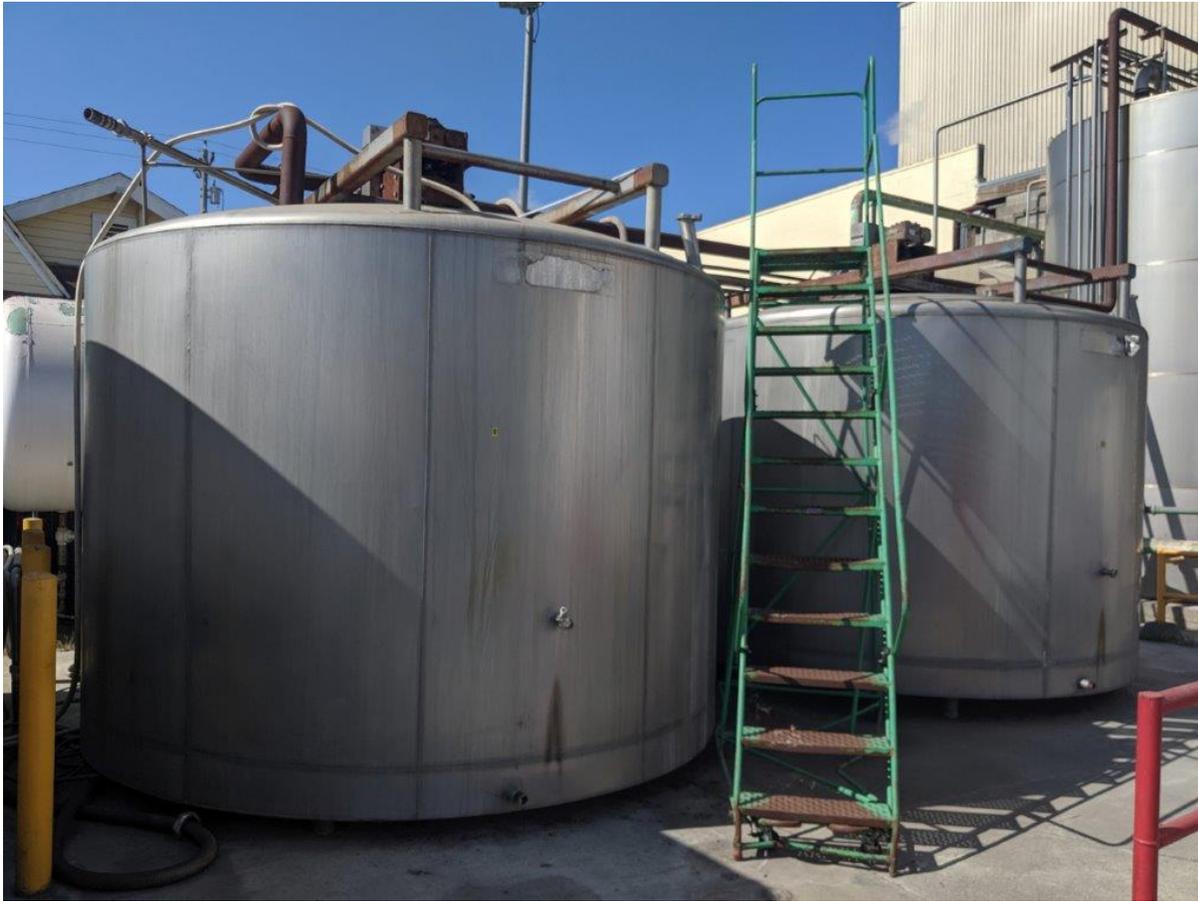
Caption 40. Ammonia Diffusion Tanks

5	Piping	A strut clamp used to fasten the RV main on the roof to a pipe support has become detached [Caption 25]. Ensure that the pipe is properly fastened to the pipe support. [ANSI/IIAR 6-2019 Appendix B Piping Checklist Item B]	3				
6	Ice Builders, Diffusion Tanks	It is unknown if the Ice Builders and Diffusion Tanks are anchored to the concrete foundation [Caption 31, Caption 34, Caption 41]. No anchors are visible on the Ice Builders and the Diffusion Tanks are	2

Item No.	Area Equip. ID	Key Findings / Recommendations	Priority Rating	Assigned To	Target Date	Completion Date	Corrective Actions
		configured with short pipe stubs which rest on the bottom of the tanks, but it is unclear if the pipes are embedded into the concrete beneath. Ensure that the above-named equipment is properly anchored to the concrete foundation. [2012 Practical Guide to Seismic Restraint Second Edition Page 139, ASCE/SEI 7-2016 §13.4, MSS-SP-58-2018 §14.2.7, ANSI/IIAR 6-2019 Table 6.1 Inspection Item S]					
7	Piping	The RV pipe associated with Ice Builder 1 Surge Drum 2 is fastened to a roof using a pipe strap that is nailed to the roof joist. The nail does not appear to be fully engaged in the wood [Caption 36]. It is recommended that the pipe strap be reinstalled to avoid loosening over time. [ANSI/IIAR 6-2019 Appendix B Piping Checklist Item B]	3				
8	Piping	Compressors 1-2 LIC pipes are supported by all-thread supports equipped with J-hangers [Video 1, Caption 38, Caption 39]. The pipes can be easily moved with a gentle push and the Compressor 2 LIC pipe is suspended above the J-hanger, rendering the support ineffective. It is recommended that the LIC pipe supports be equipped with sway bracing and the Compressor 2 LIC J-hanger adjusted so that the pipe rests on the support. [ANSI/IIAR 6-2019 Table 11.1 Inspection Items D-G, ASME B31.5-2016 §521.1.3, ANSI/IIAR 2-2014 Addendum A Appendix F Table F.1]	2

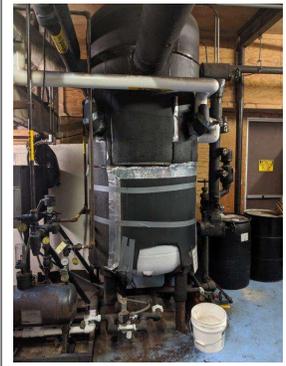
110: The Main Suction Accumulator has been in service since 1989 and has shown no indication of being undersized.

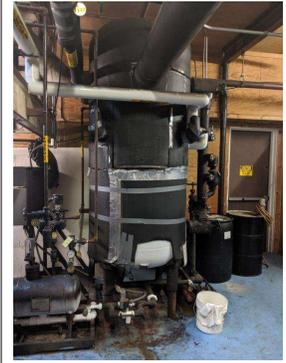
111: The main suction accumulator is equipped with a high level float switch which will shut the compressors off and initiate an alarm if the liquid level becomes too high in the main suction accumulator.

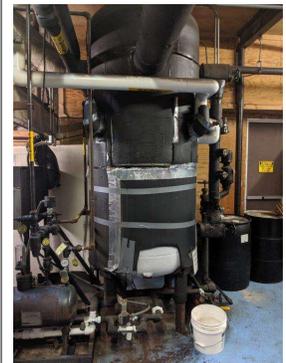
112: The main suction accumulator is located inside the machinery room which is restricted to authorized personnel only.

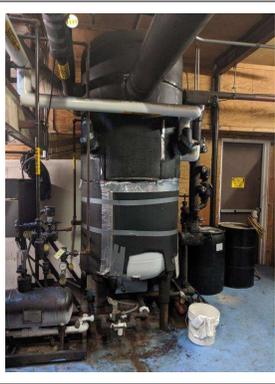
<p>119: The refrigeration system is equipped with a main suction accumulator which would collect the excess liquid before allowing it to enter the compressors.</p>

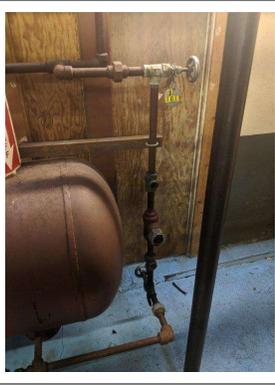
<p>120: The sight glass on the high pressure receiver is a bull's eye column type which can withstand most minor physical impact.</p>
